Manhole Inspection Summary

Manhole # S27AA_019MH

Insp Date: **11/27/07 11:17 AM**

Location Address: **837 FREMONT-MYRTLE**

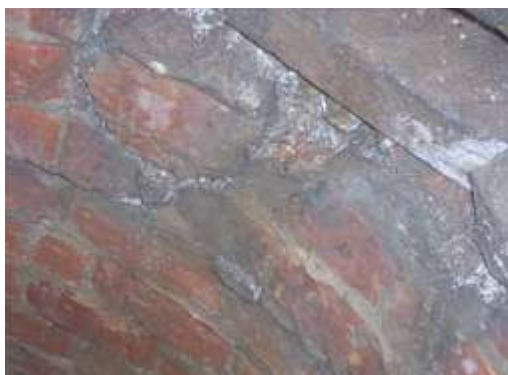
Defect 4

Condition: ☐ Sound ☒ **Cracked** ☐ Root Intrusion ☒ **Loose Brick** ☐ Deteriorated

CRACKED CORBEL

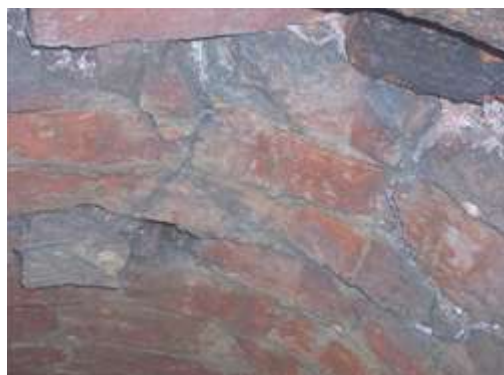
Defect 3

LOOSE CORBEL BRICK

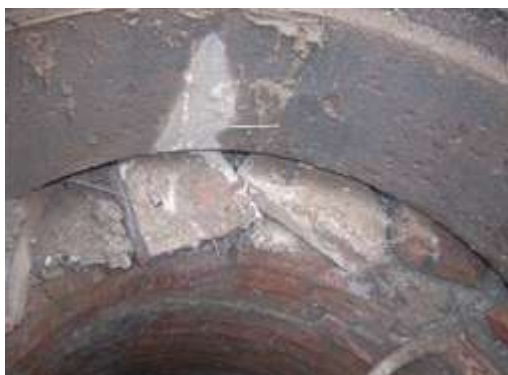
Defect 2

Condition: ☐ Sound ☐ Cracked ☐ Root Intrusion ☒ **Loose Brick** ☐ Deteriorated

LOOSE CHIMNEY BRICKS

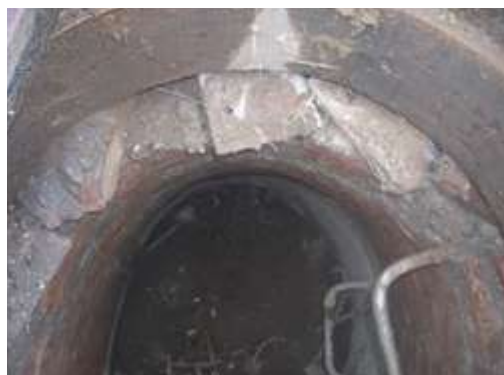
Defect 1

Frame Offset: **3** (in.) Condition: ☒ Sound ☐ Cracked ☐ Leaks

FRAME OFFSET

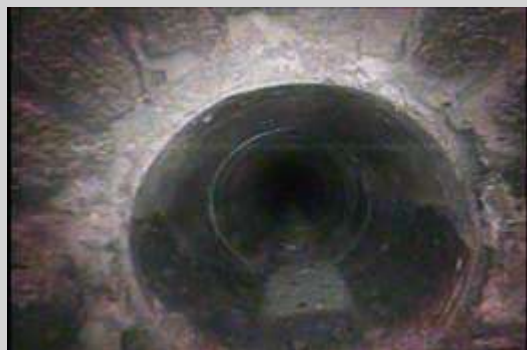
12 O'Clock Outflow

8 in. Circular Gravity Sewer
Pipe Out @ 12 O'Clock

Infiltration: **None** Pipe Seal Cond: **Sound**
